**Flood Control Project Maintenance
Levee Inspections**

Fall 2013 Levee Maintenance Deficiency Summary Report

Reclamation District No. 0563 Tyler Island

Waterway			Bank	Unit Miles
Unit No. 01 Georgiana Slough (Tyler Island)			Left	12.38
	Spring (March - May)	Summer (June - August)	(September - November) Fall	Winter (December - February)
Unit Maintenance Rating (Fall Only)			U	
Date of Inspection	04/24/2013 - 04/24/2013		10/15/2013 - 10/16/2013	
DWR Inspector	Richard Willoughby		Richard Willoughby	
Accompanied By	Steve Mello RD 563		Steve Mello RD 563

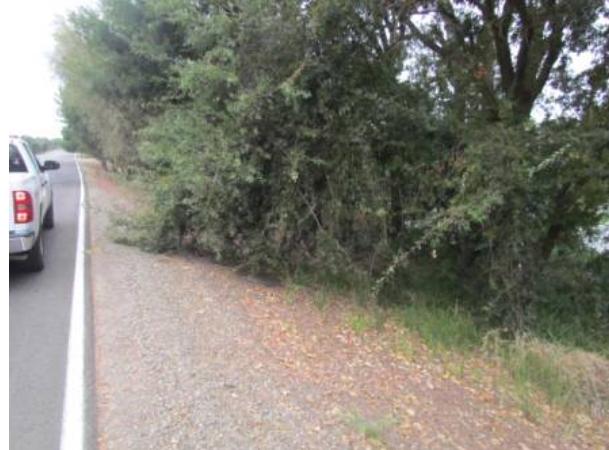
Levee Mile Report Line	6
Start Levee Mile	0.13
End Levee Mile	0.13
Location	Water Side
Category	Earthen Levee
Item	Trim / Thin Trees
Looking southwest at overgrown tree on waterside slope.	
richard_f_20130930_589.jpg

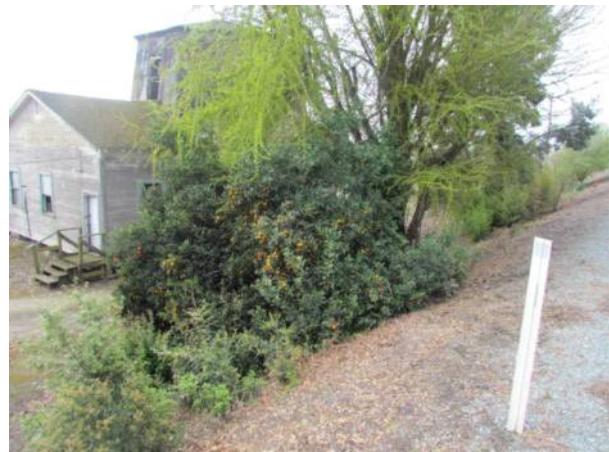
Levee Mile Report Line	7
Start Levee Mile	0.14
End Levee Mile	0.16
Location	Land Side
Category	Earthen Levee
Item	Trim / Thin Trees
Looking southeast at landscaping on landside slope and toe.	
richard_f_20130930_610.jpg

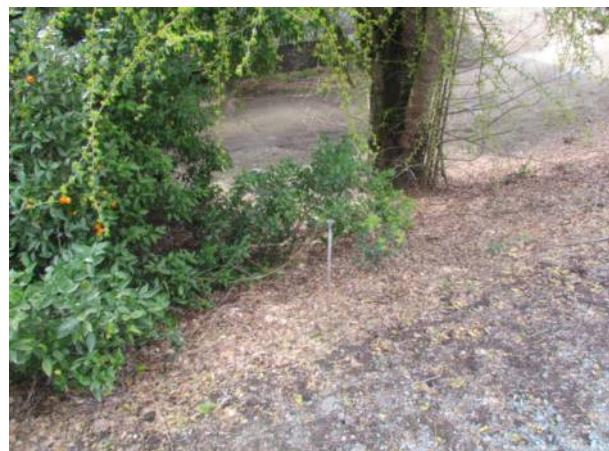
Levee Mile Report Line	7
Start Levee Mile	0.14
End Levee Mile	0.16
Location	Land Side
Category	Earthen Levee
Item	Trim / Thin Trees
Looking east at sprinklers on landside slope.	
richard_f_20130930_611.jpg

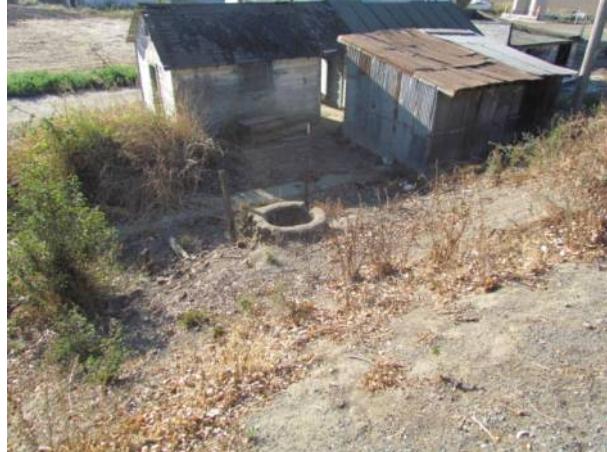
Levee Mile Report Line	8
Start Levee Mile	0.17
End Levee Mile	0.17
Location	Land Side
Category	Earthen Levee
Item	Encroachments
Looking east at fire pit on landward slope.	
richard_f_20131021_093.JPG

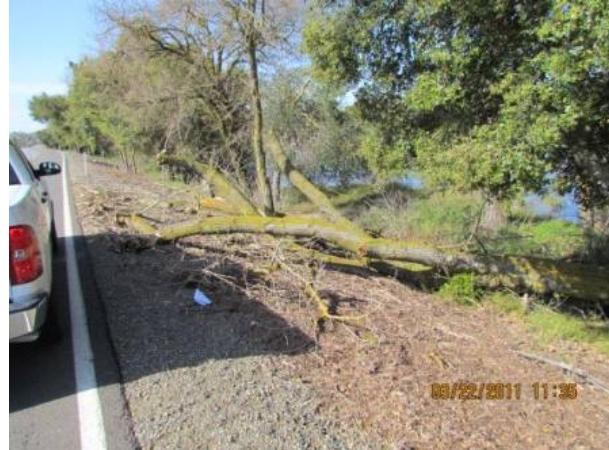
Levee Mile Report Line	9
Start Levee Mile	0.19
End Levee Mile	0.19
Location	Water Side
Category	Earthen Levee
Item	Encroachments
Looking south (downstream) at fallen tree limb on waterside slope.	
richard_f_20130930_612.jpg

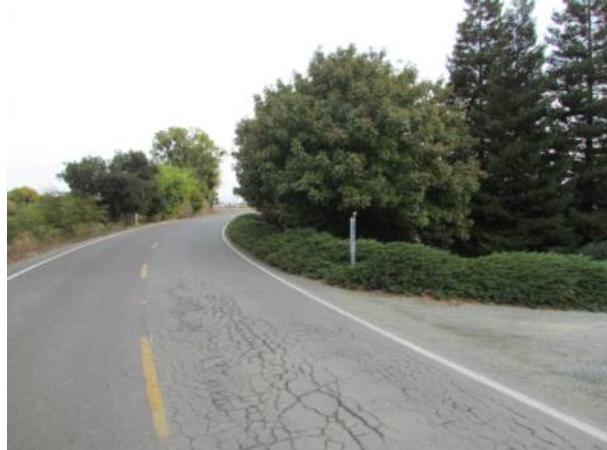
Levee Mile Report Line	15
Start Levee Mile	0.68
End Levee Mile	0.71
Location	Land Side
Category	Earthen Levee
Item	Vegetation
Looking northwest at dense landscaping on landside slope.	
richard_f_20130930_660.JPG

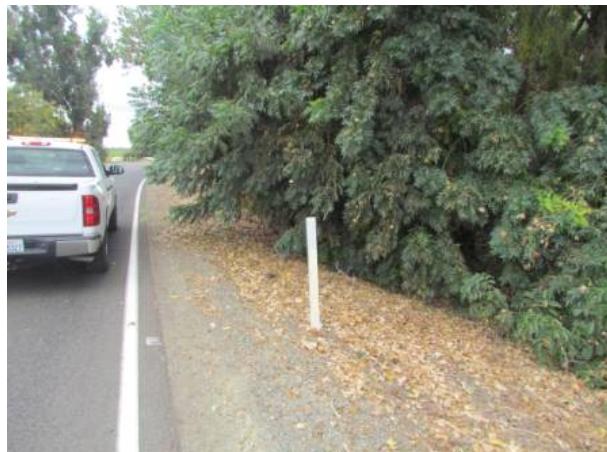
Levee Mile Report Line	17
Start Levee Mile	0.80
End Levee Mile	0.80
Location	Water Side
Category	Earthen Levee
Item	Trim / Thin Trees
Looking southwest at overgrown trees on waterside slope.	
richard_f_20130930_587.jpg

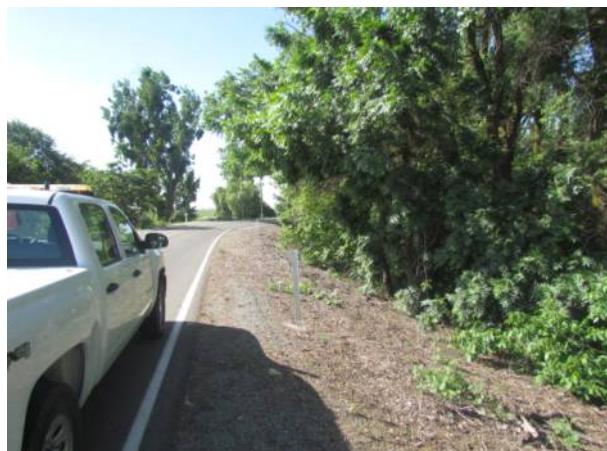
Levee Mile Report Line	17
Start Levee Mile	0.80
End Levee Mile	0.80
Location	Water Side
Category	Earthen Levee
Item	Trim / Thin Trees
Looking south at trimmed trees on waterward slope. (Spring 2013)	
richard_f_20130930_588.JPG

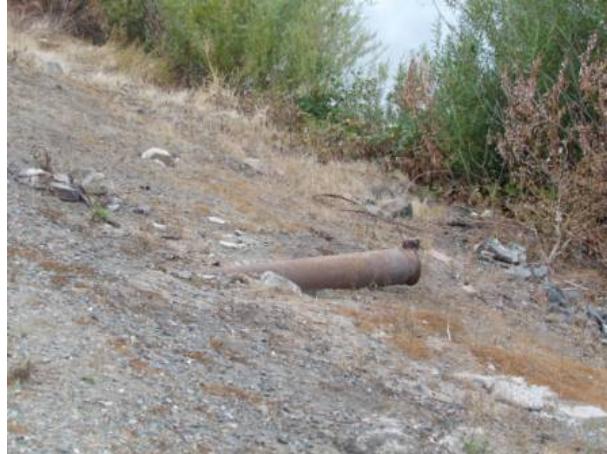
Levee Mile Report Line	21
Start Levee Mile	0.98
End Levee Mile	0.98
Location	Crown
Category	Earthen Levee
Item	Encroachments
Looking southwest at pipe on waterside slope.	
richard_f_20130930_730.jpg

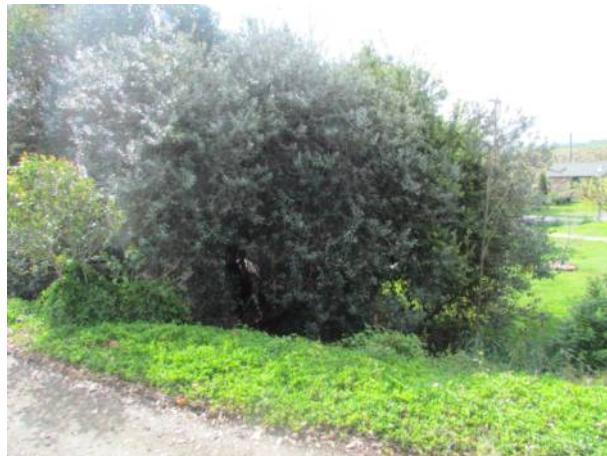
Looking east at landscaping on landside slope.

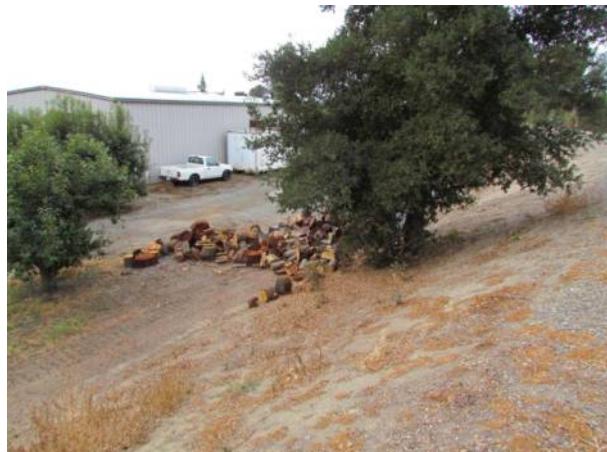
Levee Mile Report Line	25
Start Levee Mile	1.21
End Levee Mile	1.21
Location	Land Side
Category	Earthen Levee
Item	Encroachments

Looking southwest at firewood at landside toe.

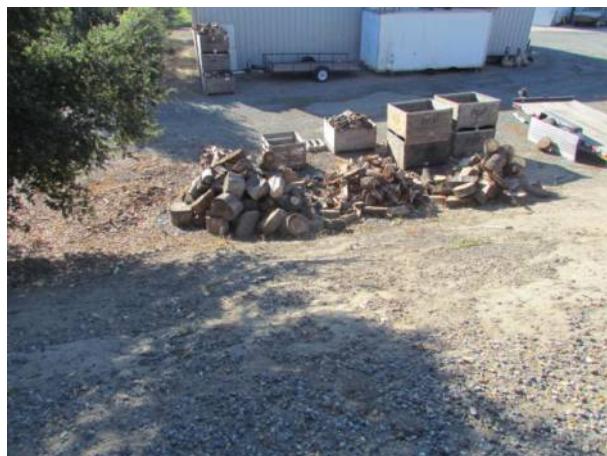
Levee Mile Report Line	25
Start Levee Mile	1.21
End Levee Mile	1.21
Location	Land Side
Category	Earthen Levee
Item	Encroachments

Looking east at firewood stacked at landward toe.

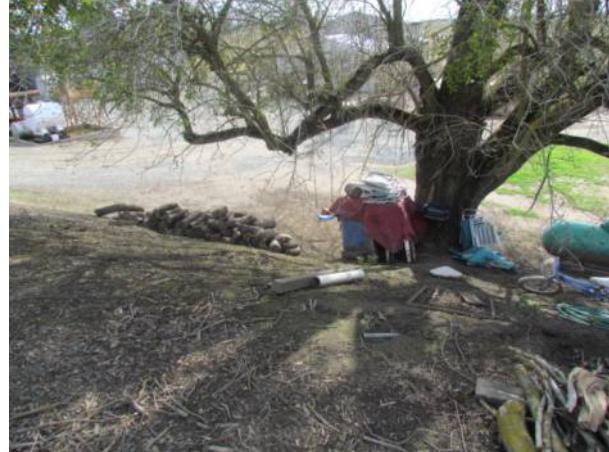
Levee Mile Report Line	29
Start Levee Mile	1.25
End Levee Mile	1.25
Location	Land Side
Category	Earthen Levee
Item	Encroachments
Looking east at firewood and other materials stored on landside slope and toe.	
richard_f_20130930_676.jpg

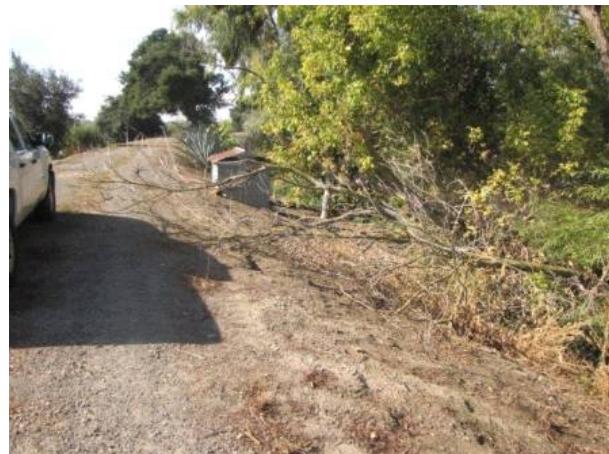
Levee Mile Report Line	33
Start Levee Mile	1.42
End Levee Mile	1.42
Location	Water Side
Category	Earthen Levee
Item	Encroachments
Looking south at a downed tree on waterside slope.	
richard_f_20130930_604.jpg

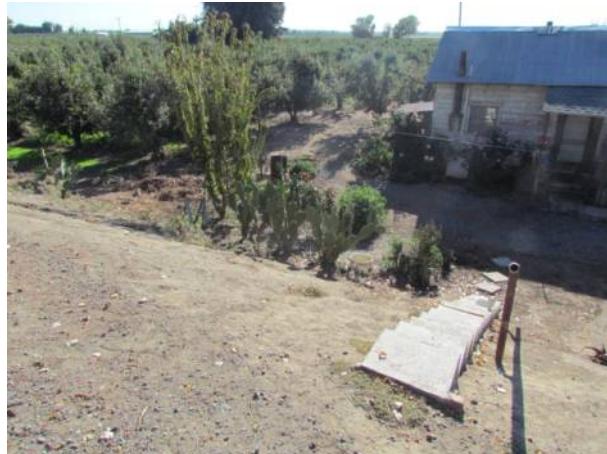
Looking east at cactus at the landward toe.

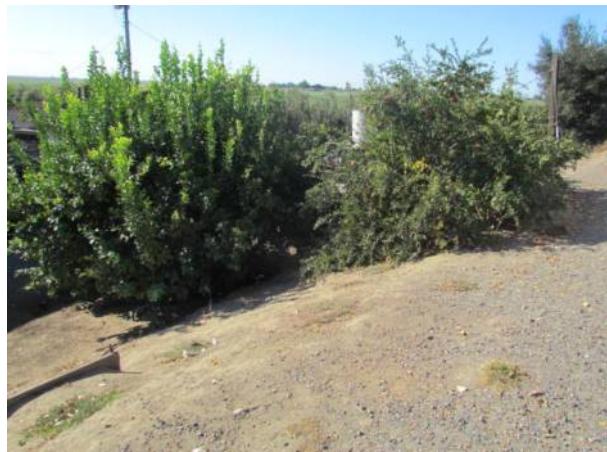
Levee Mile Report Line	34
Start Levee Mile	1.43
End Levee Mile	1.43
Location	Land Side
Category	Earthen Levee
Item	Vegetation

Looking southeast at dense landscaping on the landward slope.

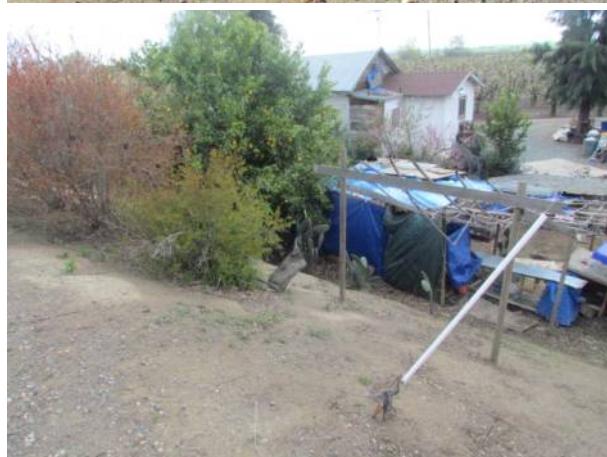
Levee Mile Report Line	35
Start Levee Mile	1.43
End Levee Mile	1.43
Location	Land Side
Category	Earthen Levee
Item	Encroachments

Looking east at landscaping and animal containers on the landside slope and toe.

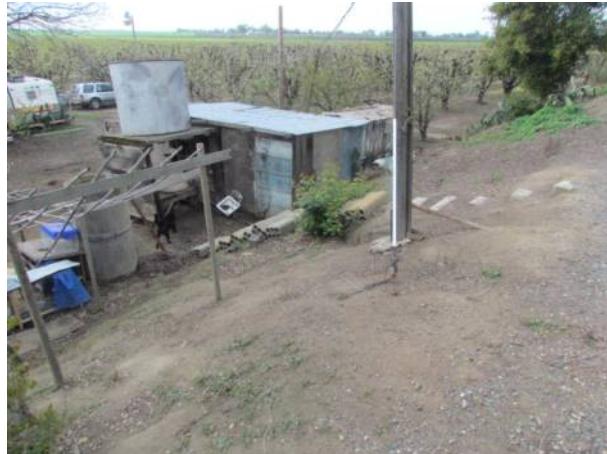
Levee Mile Report Line	35
Start Levee Mile	1.43
End Levee Mile	1.43
Location	Land Side
Category	Earthen Levee
Item	Encroachments
Looking southeast at a tool shed at the landside toe.	
richard_f_20130930_593.jpg

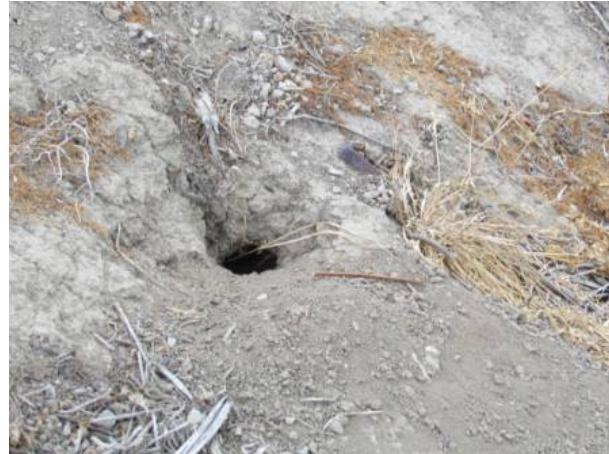
Levee Mile Report Line	40
Start Levee Mile	1.68
End Levee Mile	1.77
Location	Land Side
Category	Earthen Levee
Item	Animal Control

Looking west at rodent hole on landside slope.

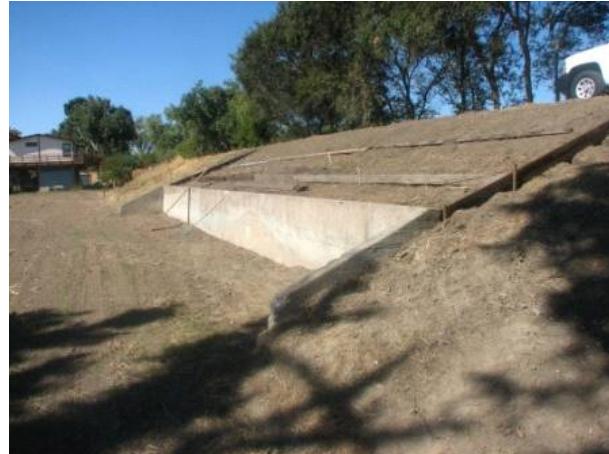
Levee Mile Report Line	41
Start Levee Mile	1.86
End Levee Mile	1.86
Location	Land Side
Category	Earthen Levee
Item	Encroachments

Unauthorized retaining wall on landside toe.

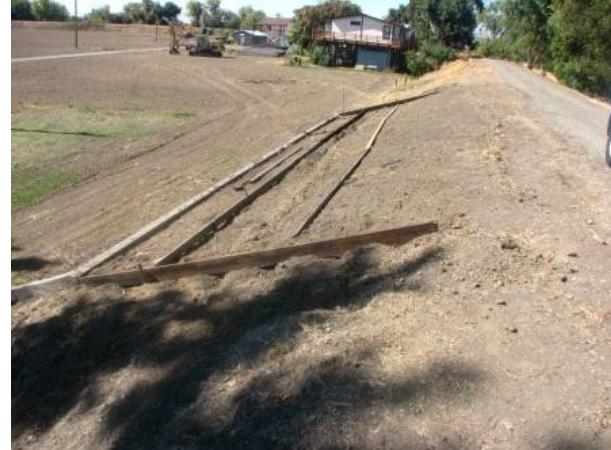
Levee Mile Report Line	41
Start Levee Mile	1.86
End Levee Mile	1.86
Location	Land Side
Category	Earthen Levee
Item	Encroachments
Looking southeast at top of retaining wall.	
richard_f_20130930_678.jpg

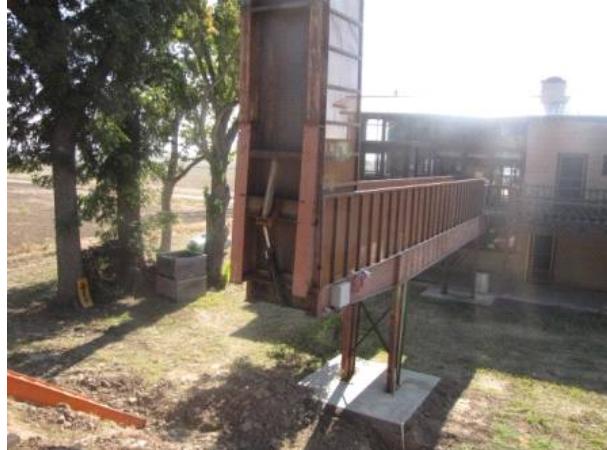
Levee Mile Report Line	41
Start Levee Mile	1.86
End Levee Mile	1.86
Location	Land Side
Category	Earthen Levee
Item	Encroachments
Looking east at metal walkway on landside.	
richard_f_20130930_684.jpg

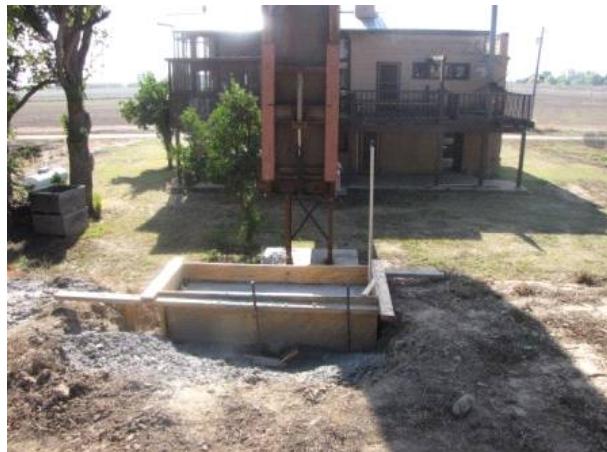
Levee Mile Report Line	41
Start Levee Mile	1.86
End Levee Mile	1.86
Location	Land Side
Category	Earthen Levee
Item	Encroachments
Looking east at deadman on landside shoulder.	
richard_f_20130930_685.jpg

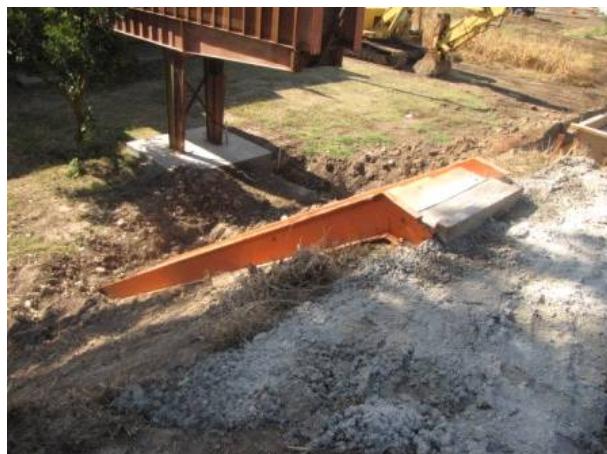
Levee Mile Report Line	41
Start Levee Mile	1.86
End Levee Mile	1.86
Location	Land Side
Category	Earthen Levee
Item	Encroachments
Looking southeast at temporary metal stairs on landside slope.	
richard_f_20130930_686.jpg

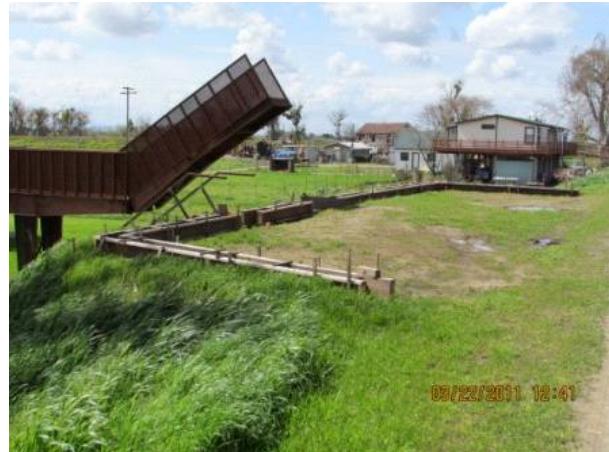
Levee Mile Report Line	41
Start Levee Mile	1.86
End Levee Mile	1.86
Location	Land Side
Category	Earthen Levee
Item	Encroachments
Looking southeast at framing for footings on landside shoulder.	
richard_f_20130930_687.jpg

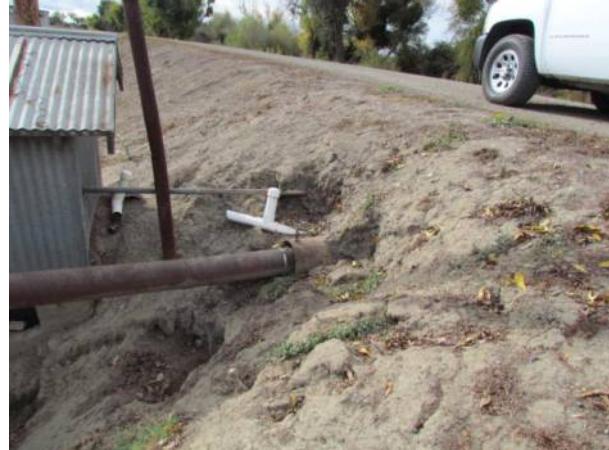
Levee Mile Report Line	43
Start Levee Mile	2.00
End Levee Mile	2.00
Location	Land Side
Category	Earthen Levee
Item	Erosion / Bank Caving
Looking southwest at erosion around irrigation pipe on landside slope and toe.	
richard_f_20130930_694.JPG

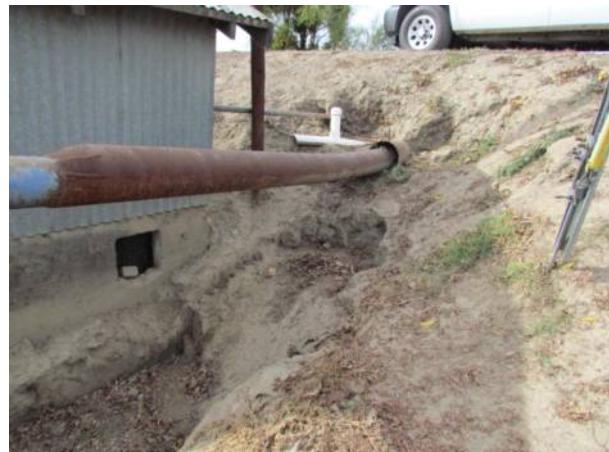
Levee Mile Report Line	43
Start Levee Mile	2.00
End Levee Mile	2.00
Location	Land Side
Category	Earthen Levee
Item	Erosion / Bank Caving
Looking west at erosion at landside toe and slope next to pump house.	
richard_f_20130930_695.JPG

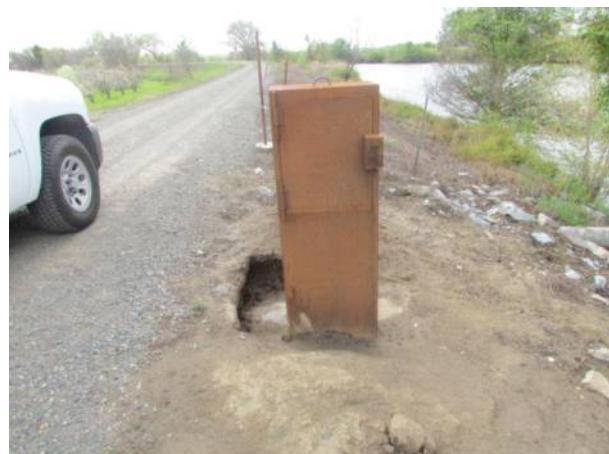
Levee Mile Report Line	45
Start Levee Mile	2.23
End Levee Mile	2.23
Location	Water Side
Category	Earthen Levee
Item	Encroachments
Looking south at siphon box installed on waterside shoulder.	
richard_f_20130930_600.jpg

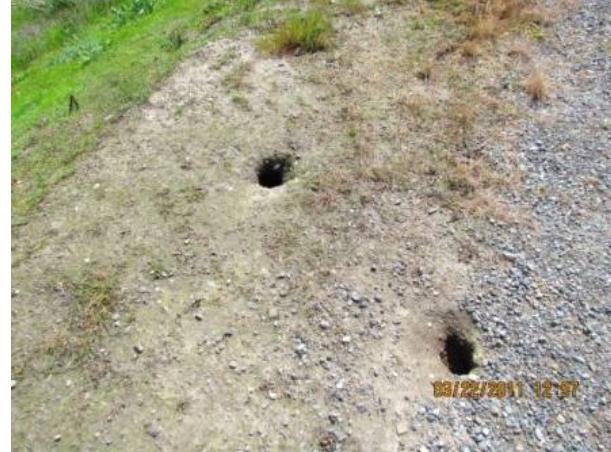
Levee Mile Report Line	46
Start Levee Mile	2.24
End Levee Mile	2.24
Location	Land Side
Category	Earthen Levee
Item	Animal Control
Looking southeast at squirrel holes on landside shoulder.	
richard_f_20130930_613.jpg

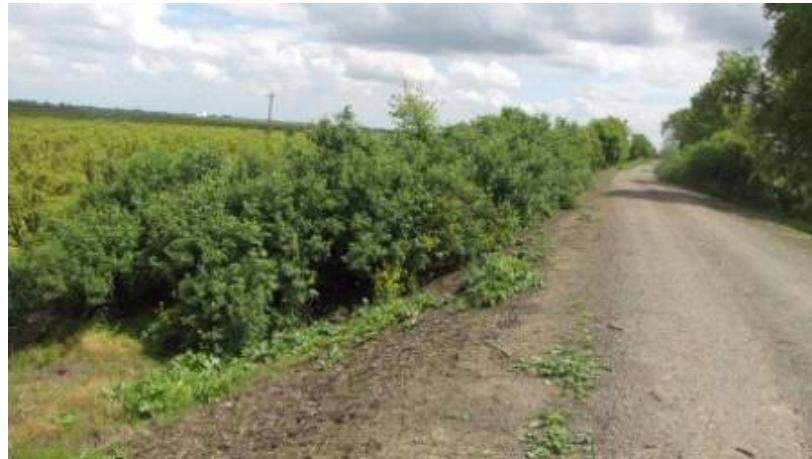
Levee Mile Report Line	48
Start Levee Mile	2.44
End Levee Mile	2.45
Location	Land Side
Category	Earthen Levee
Item	Vegetation
Looking southeast at elderberry on the landside slope and toe.	
richard_f_20130930_596.jpg

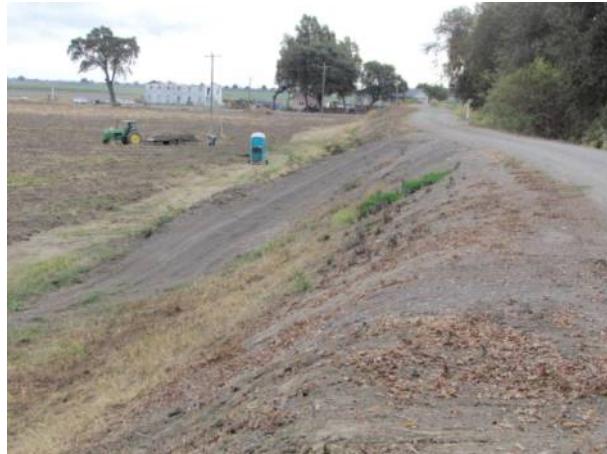
Levee Mile Report Line	49
Start Levee Mile	2.44
End Levee Mile	2.44
Location	Land Side
Category	Earthen Levee
Item	Encroachments
Looking south at unauthorized ramp on landside slope.	
richard_f_20130930_696.JPG

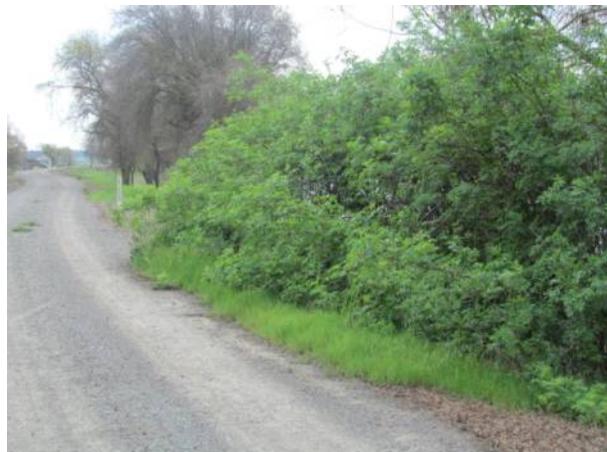
Levee Mile Report Line	50
Start Levee Mile	2.46
End Levee Mile	2.46
Location	Water Side
Category	Earthen Levee
Item	Vegetation
Looking southwest at dense elderberry brush on waterside shoulder and slope.	
richard_f_20130930_598.jpg

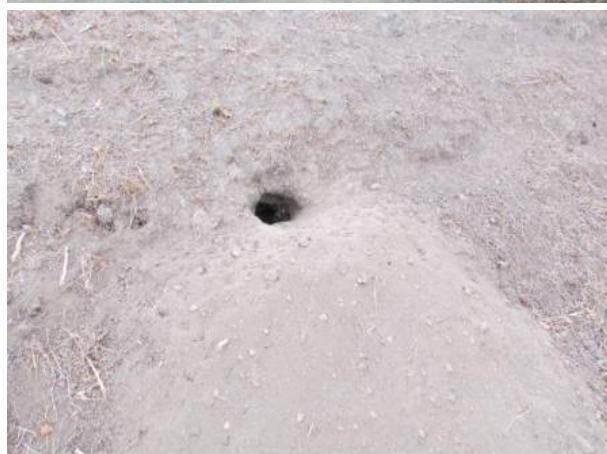
Levee Mile Report Line	51
Start Levee Mile	2.58
End Levee Mile	2.61
Location	Land Side
Category	Earthen Levee
Item	Animal Control
Looking west at rodent hole on landside slope.	
richard_f_20130930_713.jpg

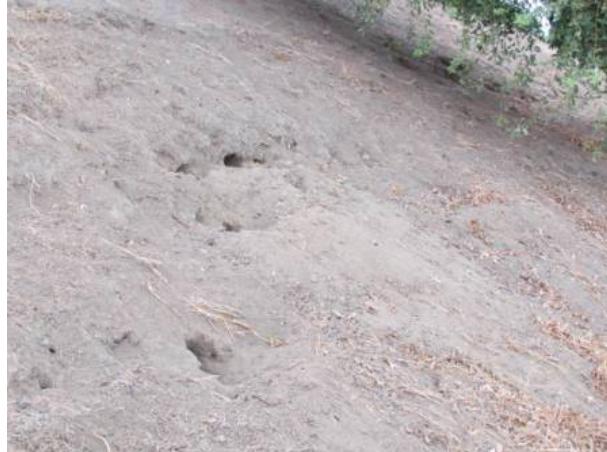
Levee Mile Report Line	51
Start Levee Mile	2.58
End Levee Mile	2.61
Location	Land Side
Category	Earthen Levee
Item	Animal Control
Looking northeast at rodent holes on landside slope.	
richard_f_20130930_714.jpg

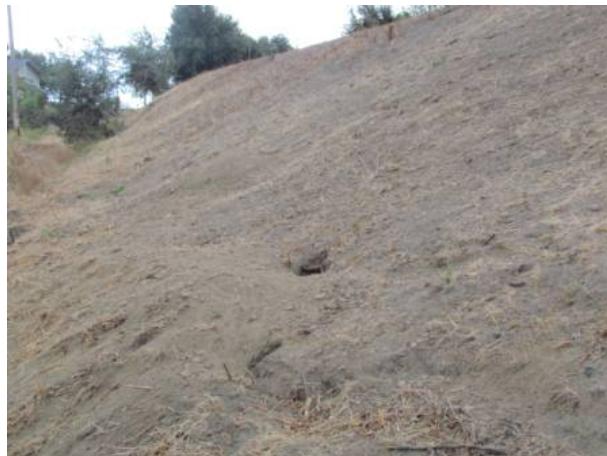
Levee Mile Report Line	51
Start Levee Mile	2.58
End Levee Mile	2.61
Location	Land Side
Category	Earthen Levee
Item	Animal Control
Looking southwest at rodent holes on landside slope.	
richard_f_20130930_715.jpg

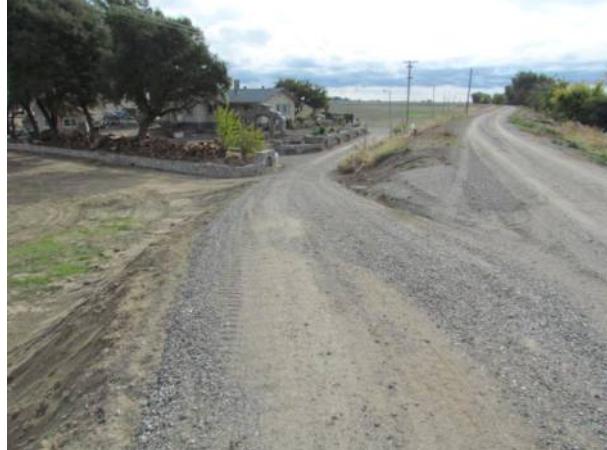
Levee Mile Report Line	53
Start Levee Mile	2.62
End Levee Mile	2.62
Location	Land Side
Category	Earthen Levee
Item	Encroachments
Looking southeast at unauthorized ramp on landside slope.	
richard_f_20130930_709.JPG

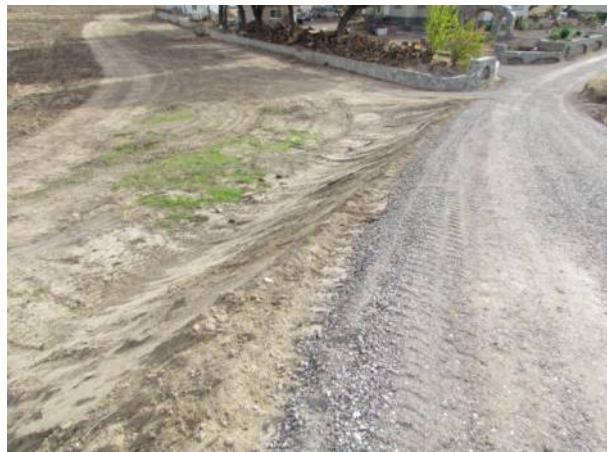
Levee Mile Report Line	53
Start Levee Mile	2.62
End Levee Mile	2.62
Location	Land Side
Category	Earthen Levee
Item	Encroachments
Looking east at unauthorized ramp on landside slope.	
richard_f_20130930_710.JPG

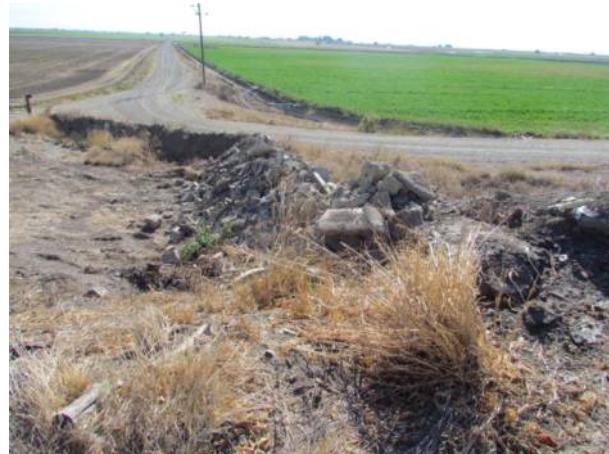
Levee Mile Report Line	56
Start Levee Mile	2.95
End Levee Mile	2.95
Location	Land Side
Category	Earthen Levee
Item	Encroachments

Looking east at concrete rubble on landward slope.

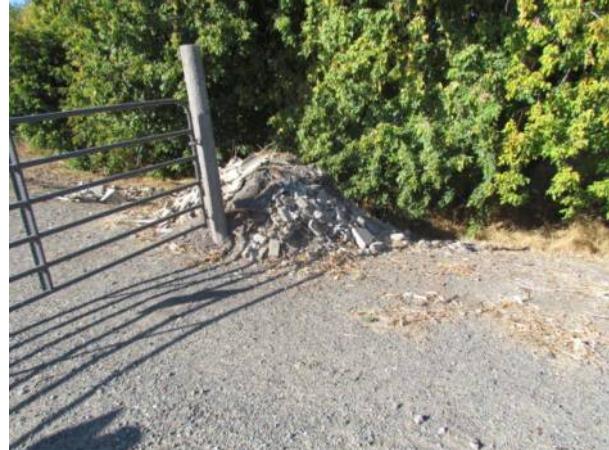
Levee Mile Report Line	56
Start Levee Mile	2.95
End Levee Mile	2.95
Location	Land Side
Category	Earthen Levee
Item	Encroachments
Looking west at concrete rubble on waterward shoulder and slope.	
richard_f_20131021_104.JPG

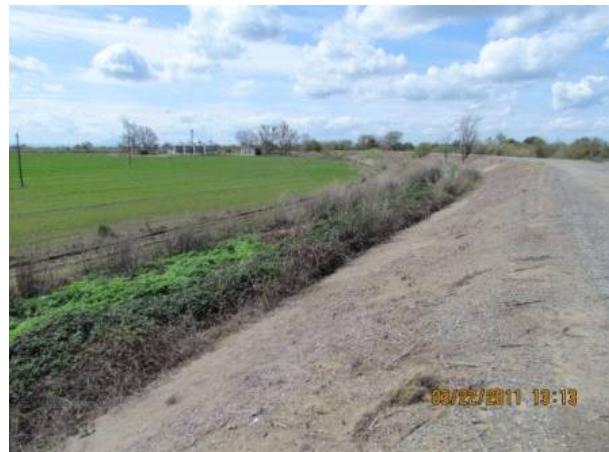
Levee Mile Report Line	58
Start Levee Mile	3.09
End Levee Mile	3.28
Location	Land Side
Category	Earthen Levee
Item	Vegetation
Looking southeast at berryvines on landside toe.	
richard_f_20130930_699.jpg

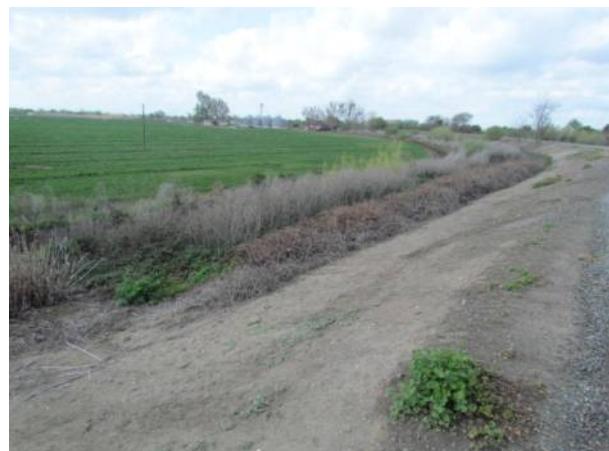
Levee Mile Report Line	58
Start Levee Mile	3.09
End Levee Mile	3.28
Location	Land Side
Category	Earthen Levee
Item	Vegetation
Looking southeast at dead berryvine on landside toe.	
richard_f_20130930_700.jpg

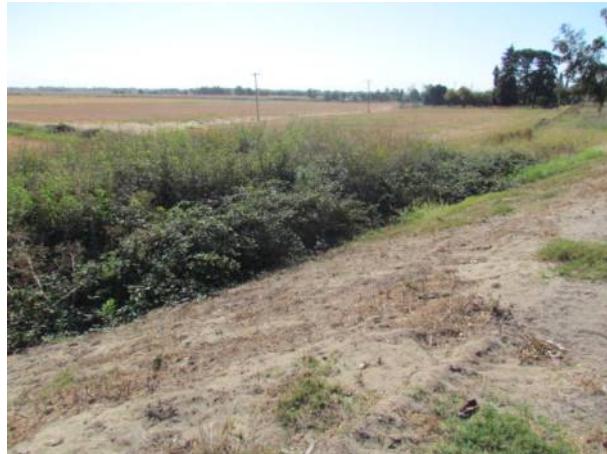
Levee Mile Report Line	62
Start Levee Mile	3.50
End Levee Mile	3.50
Location	Land Side
Category	Earthen Levee
Item	Vegetation
Looking southeast at dense berryvines on landward toe.	
richard_f_20131021_107.JPG

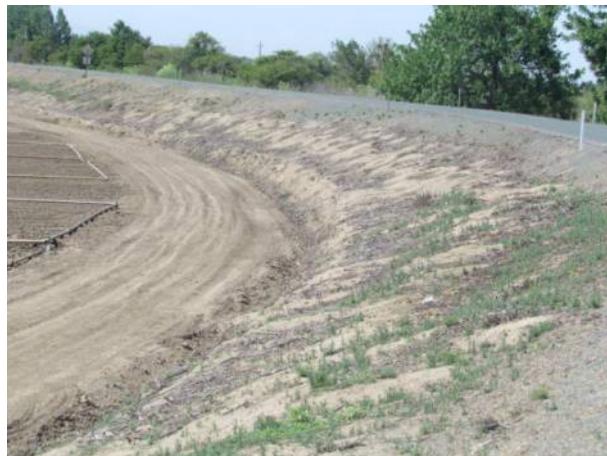
Levee Mile Report Line	64
Start Levee Mile	4.05
End Levee Mile	4.19
Location	Land Side
Category	Earthen Levee
Item	Encroachments

Looking southwest at irrigation ditch on landward toe.

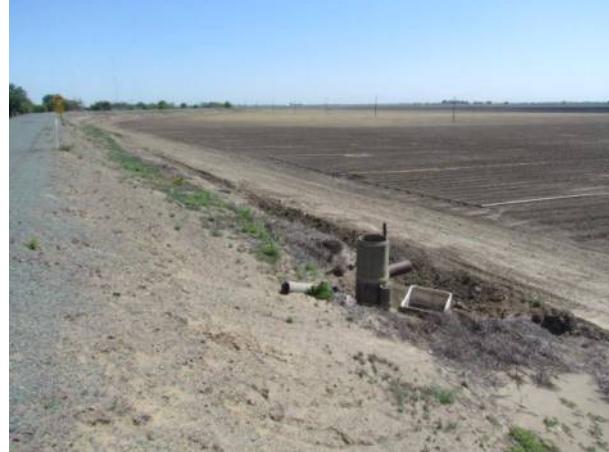
Levee Mile Report Line	64
Start Levee Mile	4.05
End Levee Mile	4.19
Location	Land Side
Category	Earthen Levee
Item	Encroachments
Looking northeast at irrigation ditch on landward toe.	
richard_f_20130930_602.JPG

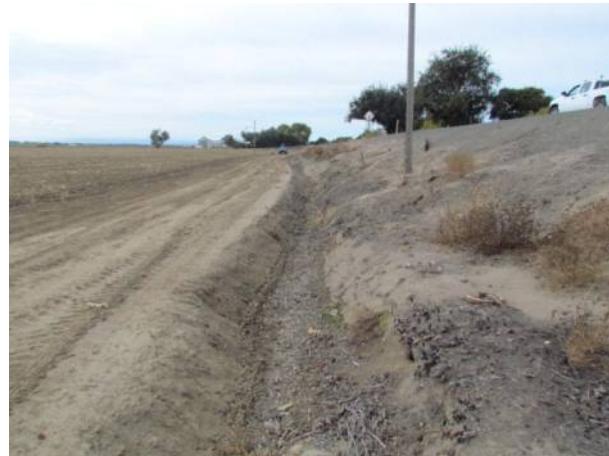
Levee Mile Report Line	65
Start Levee Mile	4.48
End Levee Mile	4.70
Location	Land Side
Category	Earthen Levee
Item	Encroachments
Looking south at irrigation ditch at landside toe.	
richard_f_20130930_726.JPG

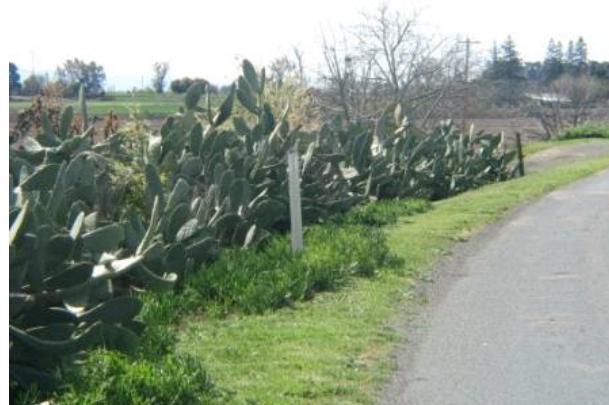
Levee Mile Report Line	71
Start Levee Mile	6.04
End Levee Mile	6.08
Location	Land Side
Category	Earthen Levee
Item	Vegetation

Large cactus plant on landward slope from LM 6.04 to 6.08

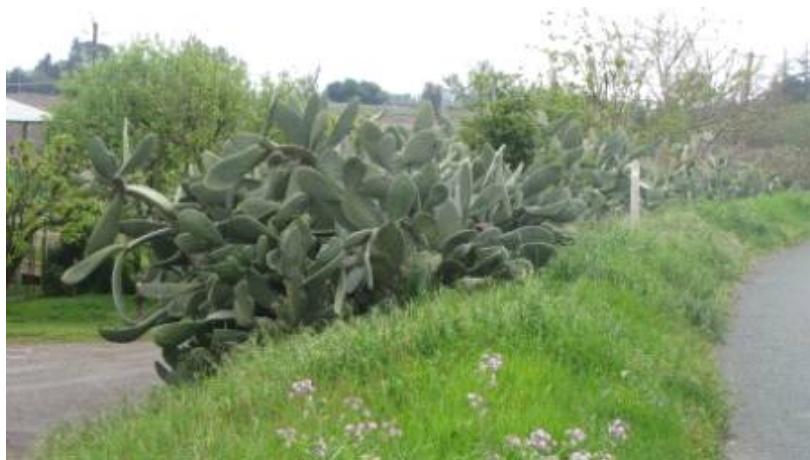
Levee Mile Report Line	71
Start Levee Mile	6.04
End Levee Mile	6.08
Location	Land Side
Category	Earthen Levee
Item	Vegetation

Looking at north end of catcus on the landside slope.

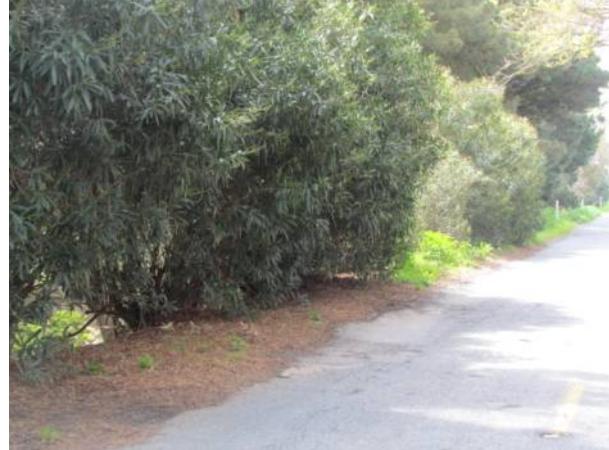
Levee Mile Report Line	76
Start Levee Mile	6.60
End Levee Mile	6.72
Location	Land Side
Category	Earthen Levee
Item	Vegetation
Looking southeast at dense landscaping on landside shoulder and slope.	
richard_f_20130930_607.jpg

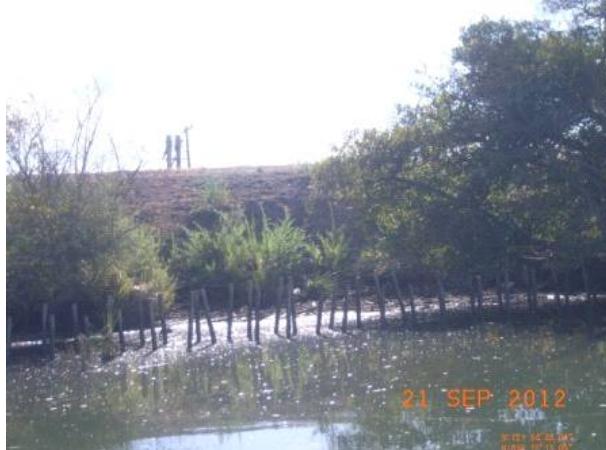
USACE 2012 Photo #3

Levee Mile Report Line	77
Start Levee Mile	6.78
End Levee Mile	7.44
Location	Water Side
Category	Supplemental
Item	USACE Erosion Survey

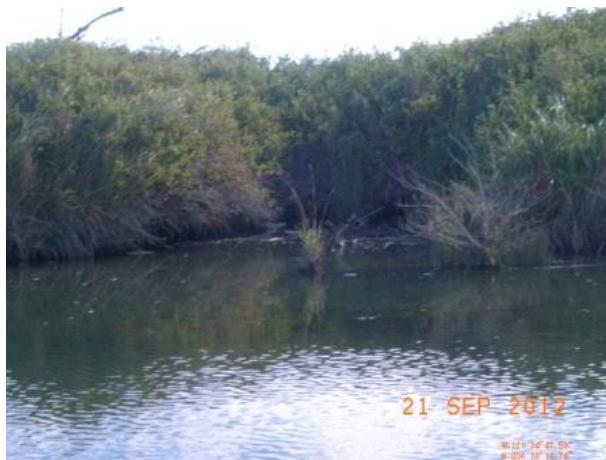
USACE 2012 Photo #4

Levee Mile Report Line	77
Start Levee Mile	6.78
End Levee Mile	7.44
Location	Water Side
Category	Supplemental
Item	USACE Erosion Survey

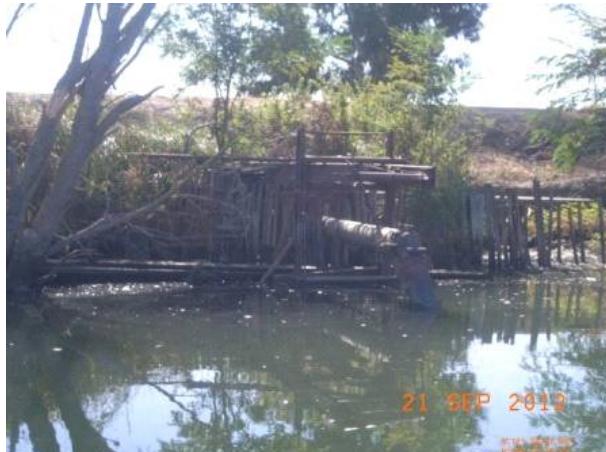
USACE 2012 Photo #5

Levee Mile Report Line	77
Start Levee Mile	6.78
End Levee Mile	7.44
Location	Water Side
Category	Supplemental
Item	USACE Erosion Survey

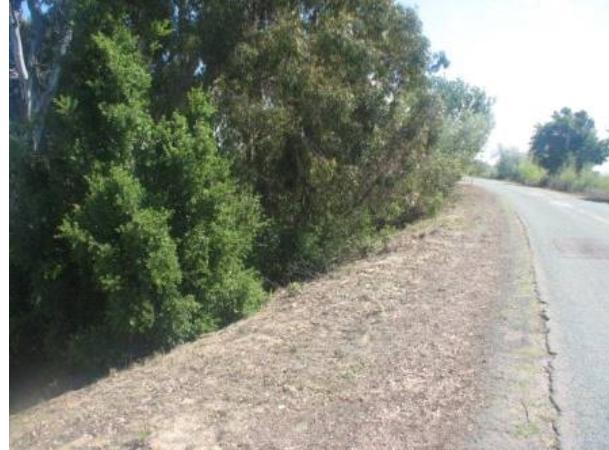
Levee Mile Report Line	79
Start Levee Mile	6.90
End Levee Mile	6.94
Location	Land Side
Category	Earthen Levee
Item	Trim / Thin Trees
Side view of dense trees along landside slope and shoulder.	
richard_f_20130930_608.jpg

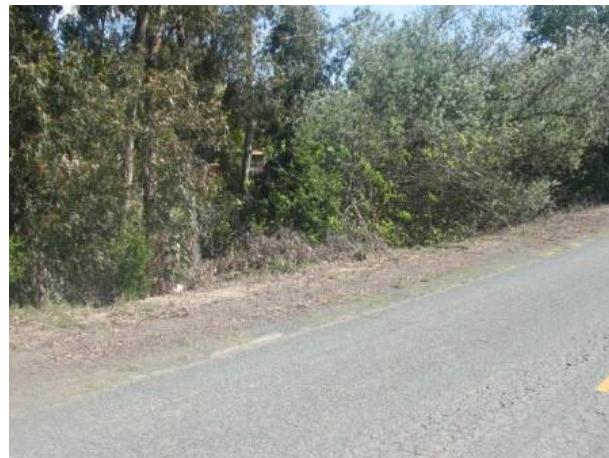
Levee Mile Report Line	79
Start Levee Mile	6.90
End Levee Mile	6.94
Location	Land Side
Category	Earthen Levee
Item	Trim / Thin Trees
Front view of dense trees along landside shoulder and slope.	
richard_f_20130930_609.jpg

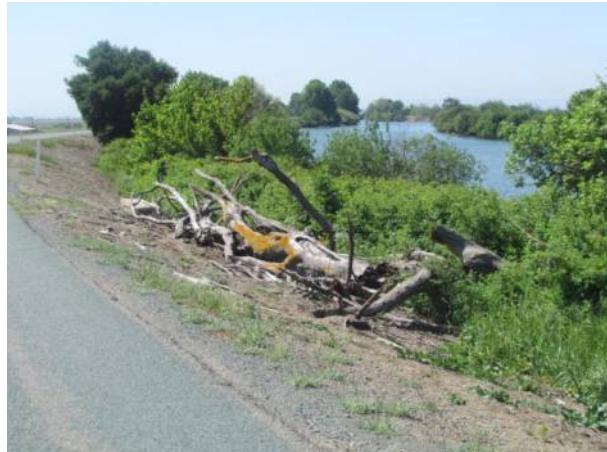
Levee Mile Report Line	83
Start Levee Mile	7.10
End Levee Mile	7.10
Location	Water Side
Category	Earthen Levee
Item	Encroachments
Looking southwest at prunings on waterward slope.	
richard_f_20130930_727.JPG

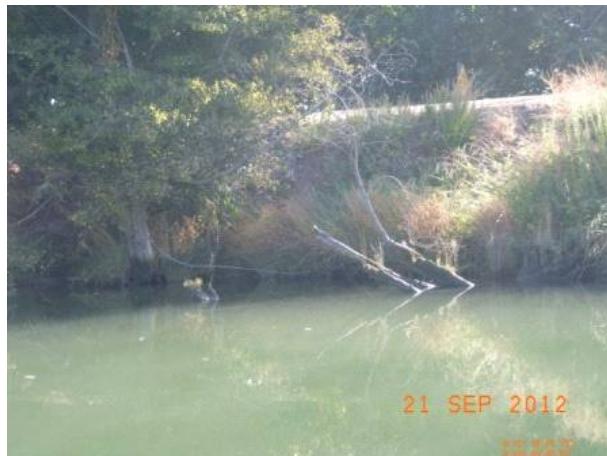
84	7.56	7.82	Supplemental USACE Erosion Survey	WS	U Ma	Inspector Comments: 1997 - Pocket erosion at upstream end and into the levee toe under the Alder trees. 2003 - New brush boxes with wattles on bank. 2004 - No brush boxes. 2005 - Site extended from the downstream side of the bridge. Whole bank is vertical. 2010 - Some minor new erosion. 2011 - Site upgraded to CRITICAL. New erosion pockets throughout the site. Sites 4.5, and 4.6 were combined. 2012: No observed change. [2012 Site ID: GEO_4-5_L]	38.164462 ° -121.583092 °	38.160888 ° -121.584807 °	45 Y	DWR ID:
85	7.66	7.66	Earthen Levee	Encroachments	WS M Ma	TR : Tree or limb Inspector Comments: Broken tree branch on waterside slope.	38.164927 ° -121.582680 °	38.164927 ° -121.582680 °	89 Y	DWR ID: DWR_RD0563_01_s_2012_89
86	7.79	7.79	Earthen Levee	Slope Stability	LS M Ma	S1 : Repair slope instability. Inspector Comments: Minor erosion on landside shoulder and slope.	38.163240 ° -121.583328 °	38.163240 ° -121.583328 °	97 Y	DWR ID: DWR_RD0563_01_s_2013_97

Levee Mile Report Line	84
Start Levee Mile	7.56
End Levee Mile	7.82
Location	Water Side
Category	Supplemental
Item	USACE Erosion Survey
USACE 2012 Photo #1	
USACE2013_GEO_4-5_L_1.jpg

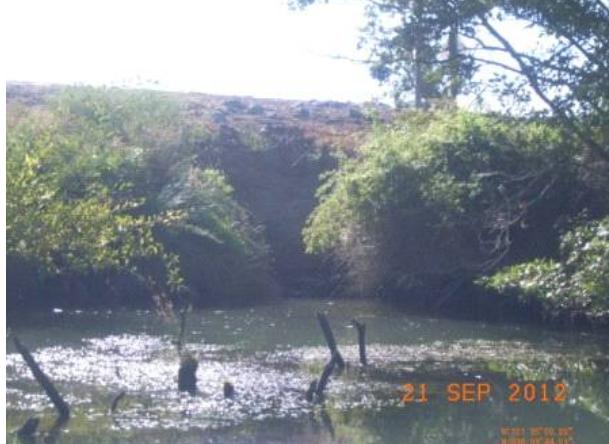
USACE 2012 Photo #3

Levee Mile Report Line	84
Start Levee Mile	7.56
End Levee Mile	7.82
Location	Water Side
Category	Supplemental
Item	USACE Erosion Survey

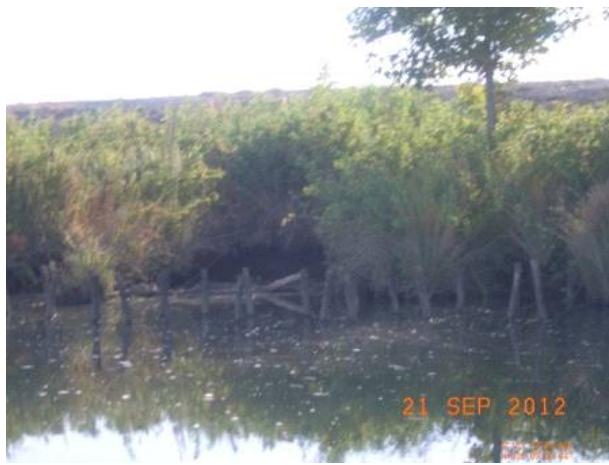
USACE 2012 Photo #4

Levee Mile Report Line	84
Start Levee Mile	7.56
End Levee Mile	7.82
Location	Water Side
Category	Supplemental
Item	USACE Erosion Survey

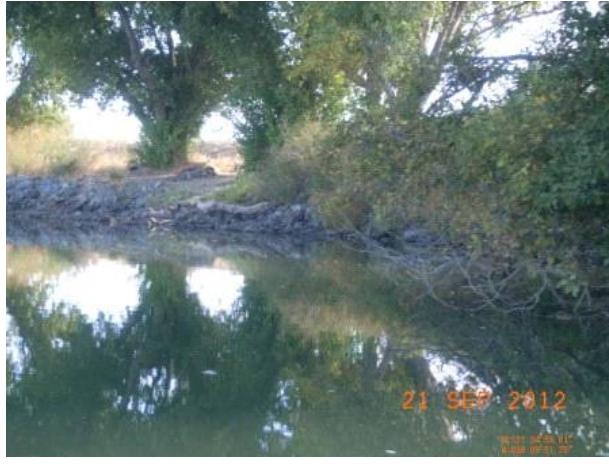
USACE 2012 Photo #5

Levee Mile Report Line	84
Start Levee Mile	7.56
End Levee Mile	7.82
Location	Water Side
Category	Supplemental
Item	USACE Erosion Survey

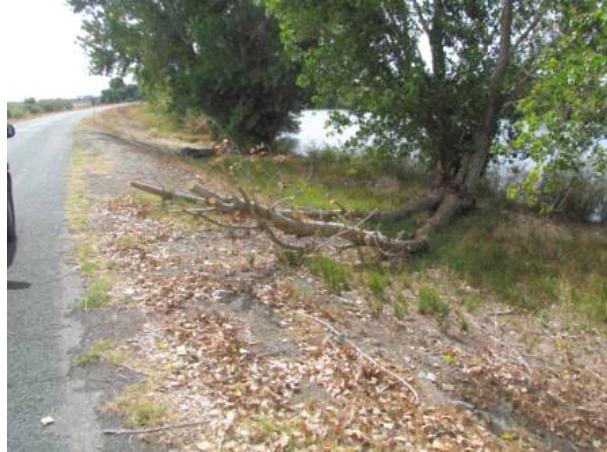
Levee Mile Report Line	85
Start Levee Mile	7.66
End Levee Mile	7.66
Location	Water Side
Category	Earthen Levee
Item	Encroachments
Looking southwest at downed limbs on waterside slope.	
richard_f_20130930_718.jpg

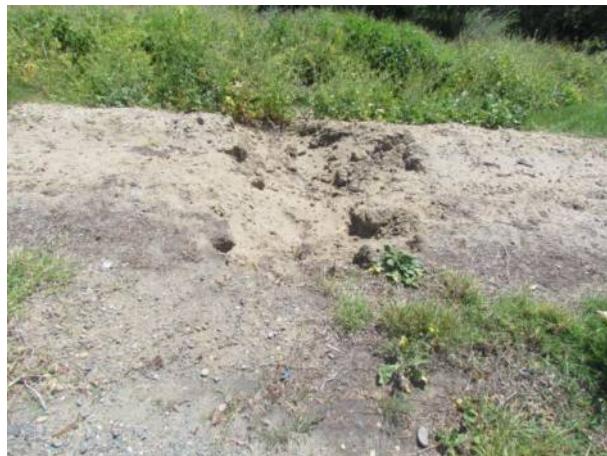
Levee Mile Report Line	86
Start Levee Mile	7.79
End Levee Mile	7.79
Location	Land Side
Category	Earthen Levee
Item	Slope Stability
Looking east at slope erosion on landward shoulder and slope.	
richard_f_20130930_728.JPG

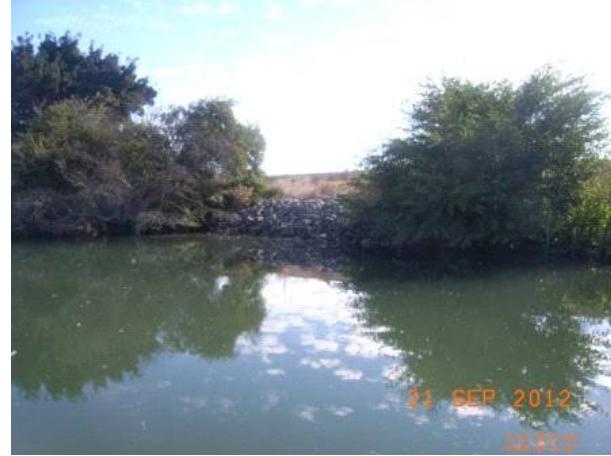
USACE 2012 Photo #2

87	7.87	8.07	Supplemental USACE Erosion Survey	WS M Ma		Inspector Comments: 1997 - Pockets of erosion into the levee toe. 1999 - Minor rock riprap and willow bundles place in a couple of spots. 2001 - Staked, low fascine walls at bankline. 2003 - Small unprotected pockets still eroding. 2004 - Numerous brush boxes, some falling apart, some with new bundles. 2005 - Some new brush boxes installed; some boxes are empty. Levee slope and banks still look bad with pocket scallops into the levee slopes. 2011 - Erosion continues and the number of pockets is increasing. 2012: No observed change. [2012 Site ID: GEO_4-3_L]	38.160261 ° -121.585056 °	38.157625 ° -121.586543 °	46 Y	DWR ID:
88	7.91	7.95	Earthen Levee	Trim / Thin Trees	LS M Ma	T1 : Trim trees to at least five feet above ground level.	38.161607 ° -121.584258 °	38.161092 ° -121.584470 °	29 Y	DWR ID: DWR_RD0563_01_s_2012_29
89	7.97	8.10	Earthen Levee	Vegetation	LS M Ma	V2 : Remove the wild growth other than native grasses from the levee slopes. Inspector Comments: Berryvines and willows on landside toe.	38.160800 ° -121.584598 °	38.160487 ° -121.584717 °	90 Y	DWR ID: DWR_RD0563_01_s_2012_90

Levee Mile Report Line	87
Start Levee Mile	7.87
End Levee Mile	8.07
Location	Water Side
Category	Supplemental
Item	USACE Erosion Survey

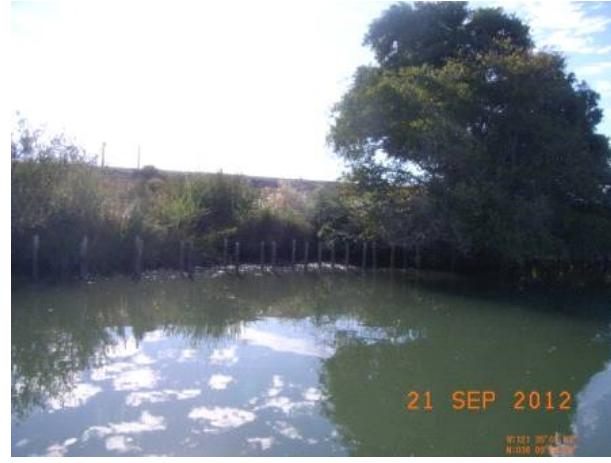
USACE 2012 Photo #3

Levee Mile Report Line	87
Start Levee Mile	7.87
End Levee Mile	8.07
Location	Water Side
Category	Supplemental
Item	USACE Erosion Survey

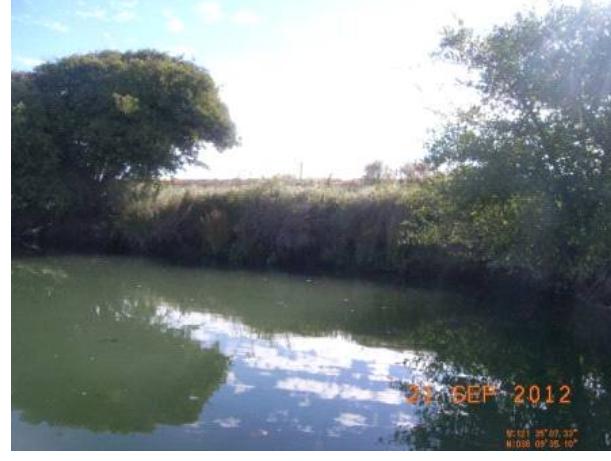
USACE 2012 Photo #4

Levee Mile Report Line	87
Start Levee Mile	7.87
End Levee Mile	8.07
Location	Water Side
Category	Supplemental
Item	USACE Erosion Survey

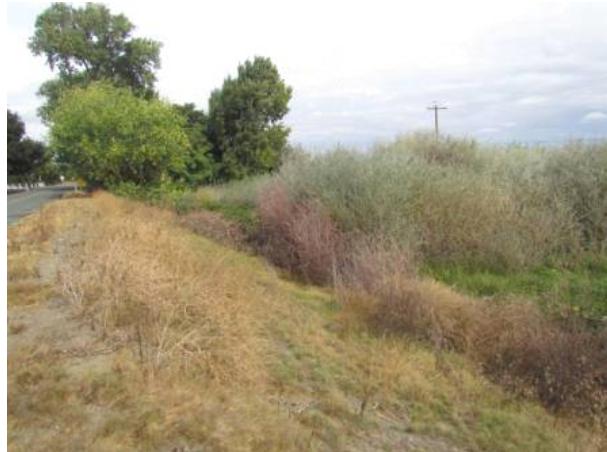
Levee Mile Report Line	89
Start Levee Mile	7.97
End Levee Mile	8.10
Location	Land Side
Category	Earthen Levee
Item	Vegetation
Looking northeast at dense vegetation on landside toe.	
richard_f_20130930_719.jpg

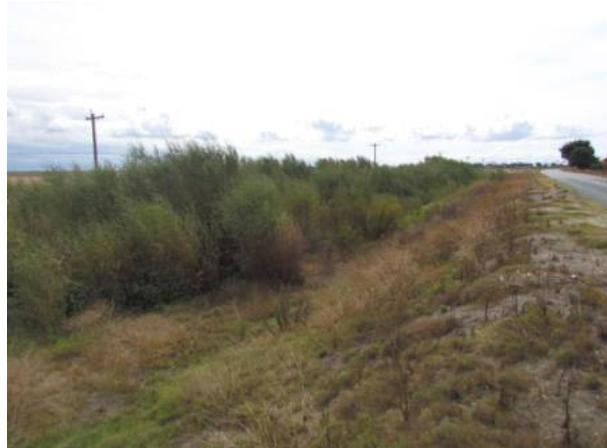
Levee Mile Report Line	89
Start Levee Mile	7.97
End Levee Mile	8.10
Location	Land Side
Category	Earthen Levee
Item	Vegetation
Looking southwest at dense vegetation on landside toe.	
richard_f_20130930_720.jpg

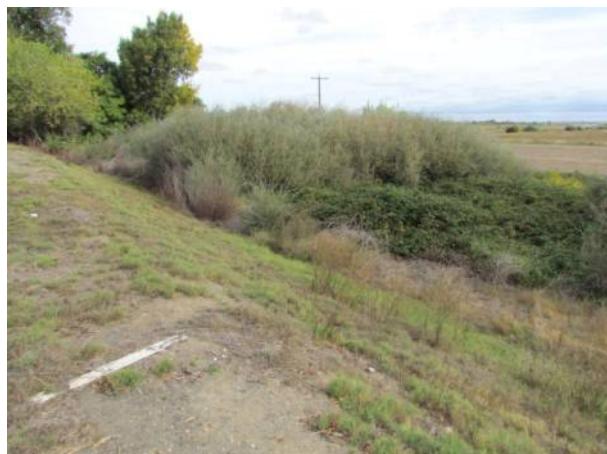
Levee Mile Report Line	89
Start Levee Mile	7.97
End Levee Mile	8.10
Location	Land Side
Category	Earthen Levee
Item	Vegetation
Looking northeast at dense vegetation on landside toe. (2012 Fall Inspection)	
richard_f_20130930_721.JPG
